This spreadsheet performs screening level calculations to estimate the effect of peeling leaded paint on the average concentration of lead in yard soil 3634 Williams St

Property # 379 / 3634 Williams Street

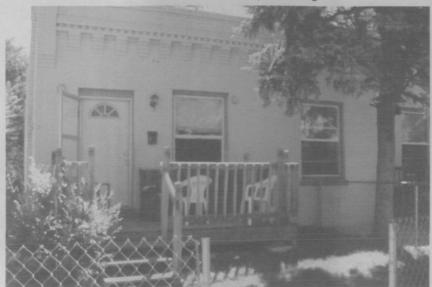
West porch exposure of house

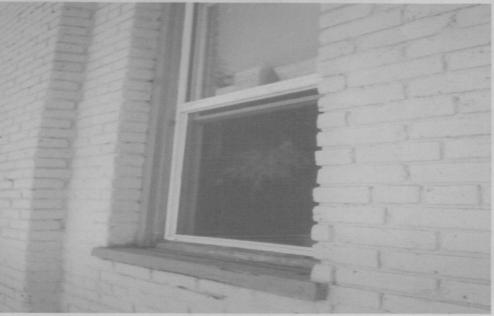
North wood window frames contain peeling lead paint

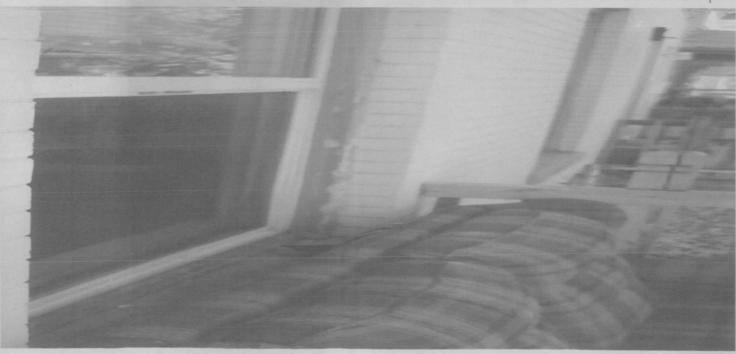
West wood window frame contains peeling lead pant
